Limited Hazardous Materials Survey

City of Lake Forest Park Lakefront Improvements Project 17345 and 17347 Beach Dr. NE Lake Forest Park, Washington

EHSI Project No. 11720

March 2024

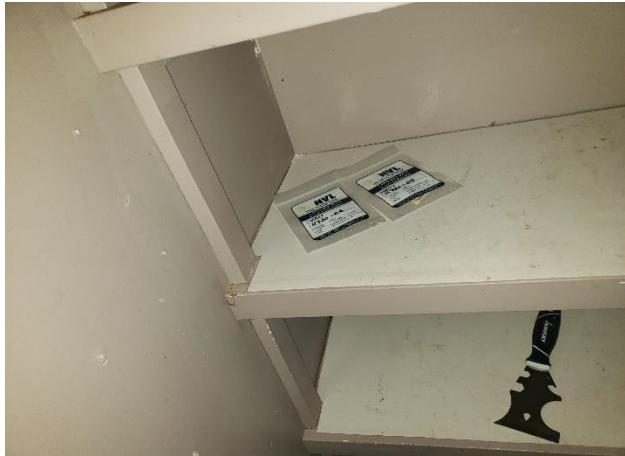
Photo #1: Samples 11720-05/05QA & 06: Beige joint compound (on GWB.) (3% Chrysotile)
Location: Building 8 Kitchen

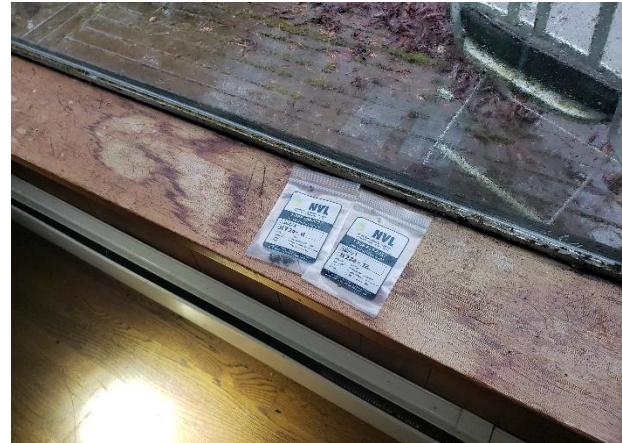
Photo #2: Samples 11720-11/11QA & 12: White interior window glazing (on 9'x11' metal frame window.) (4% Chrysotile)
Location: Building 8 Living Room Interior

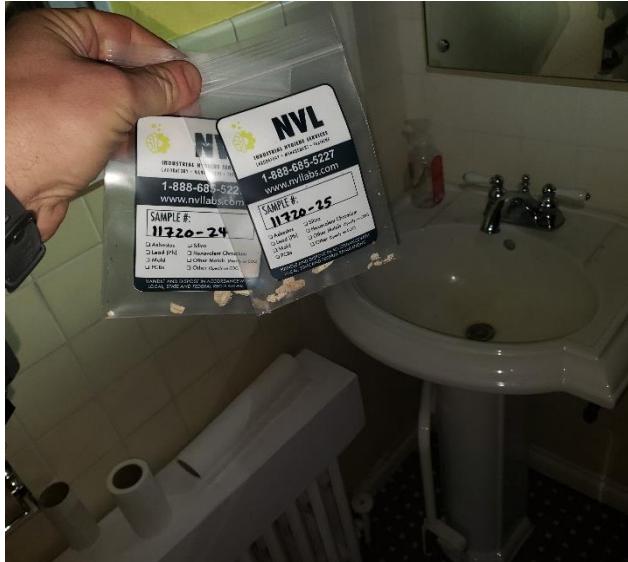
Photo #3: Samples 11720-24 & 25: 4"x4" cream ceramic tile with gray grout (on plaster.) (4% Chrysotile)
Location: Building 8 Entryway Bathroom

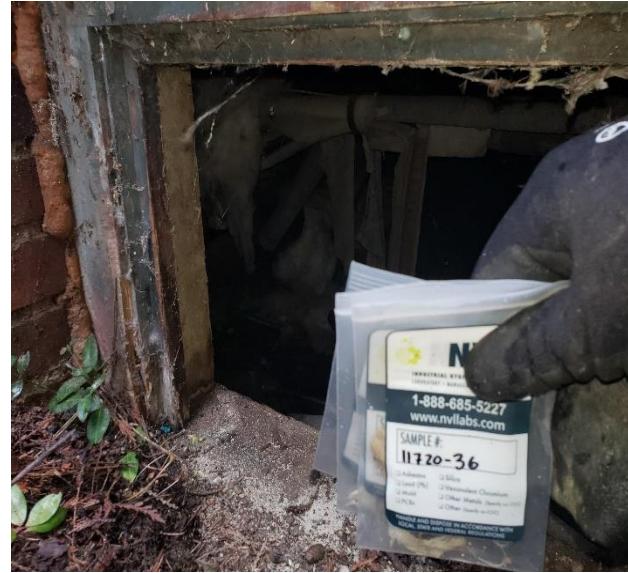
Photo #4: Sample 11720-36 through 38 & 60/60QA & 61: TSI (on 3" OD metal hot water piping). (44% Chrysotile)
Location: Building 8 Crawl Space and East Garage Building

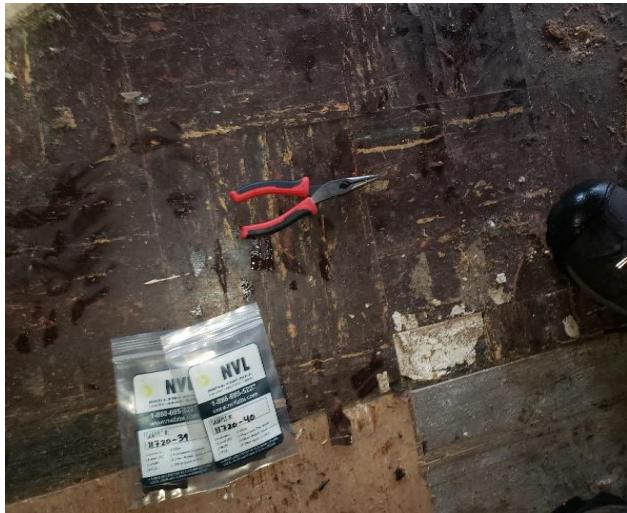
Photo #5: Samples 11720-39 & 40: 9"x9" Brown VFT on black mastic (on wood.) (9% Chrysotile)
Location: Building 9 Main Floor

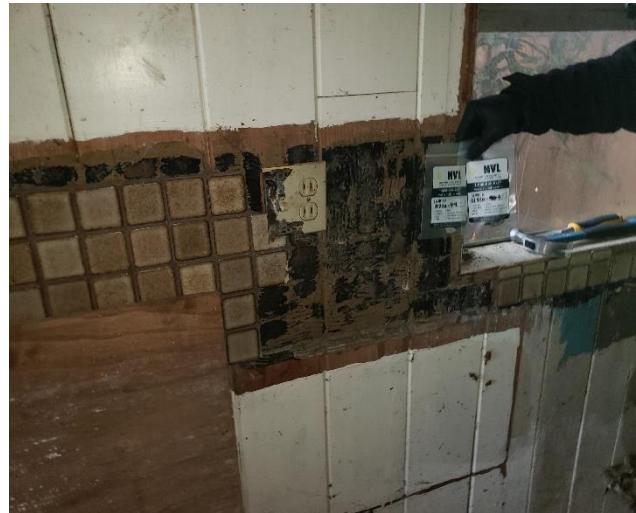
Photo #6: Samples 11720-44 & 45: 2"x2" Olive ceramic tile on yellow mastic on black mastic and 4"x3" white ceramic tile with yellow mastic (on wood.) (2% Chrysotile)
Location: Building 9 Shower Area

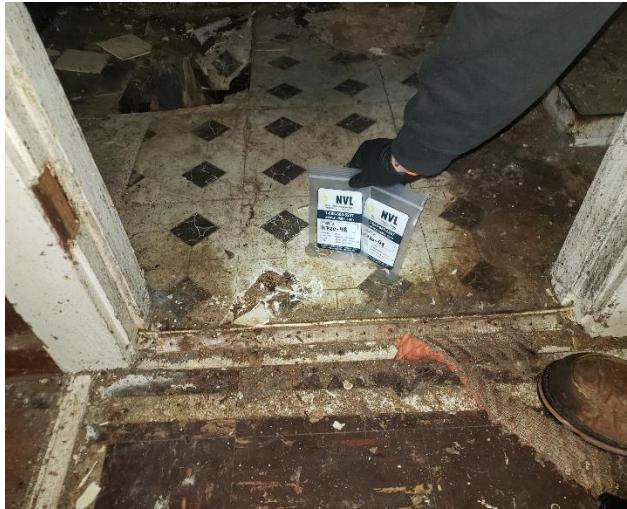
Photo #7: Samples 11720-48 & 49: 12"x12" White and black VFT on brown mastic (on wood) (46% Chrysotile)
Location: Building 9 Bathroom

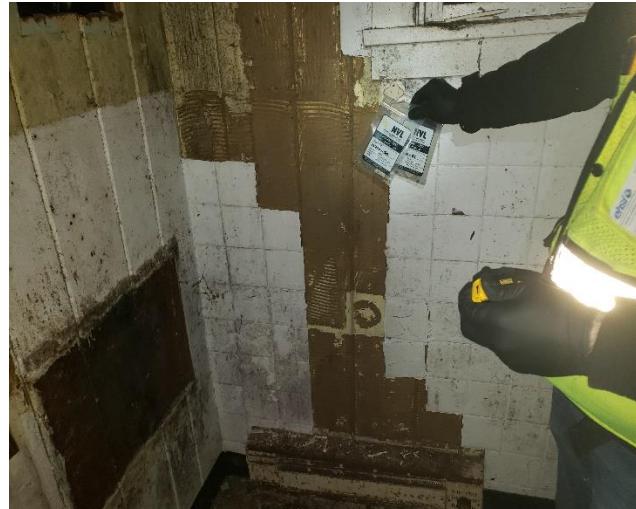
Photo #8: Samples 11720-50 & 51: 4"x4" White ceramic tile on gray grout on brown mastic (on wood paneling.) (4% Chrysotile)
Location: Building 9 Bathroom

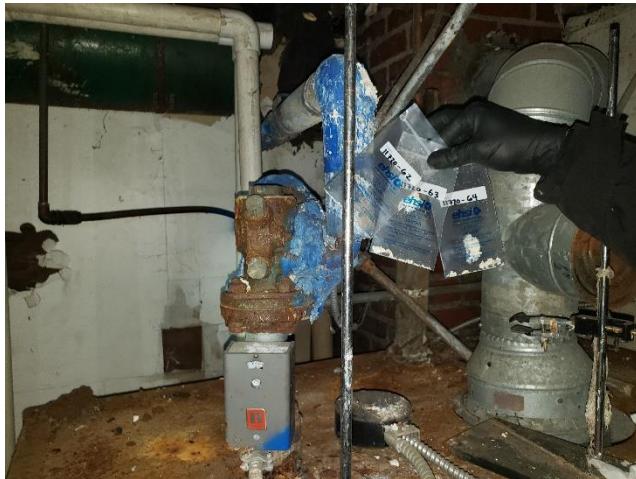
Photo #9: Samples 11720-62,63 & 64: Blue and white muddled elbows (on 4" OD metal boiler piping.) (12% Chrysotile, 5% Amosite)
Location: Building 7 Garage Area

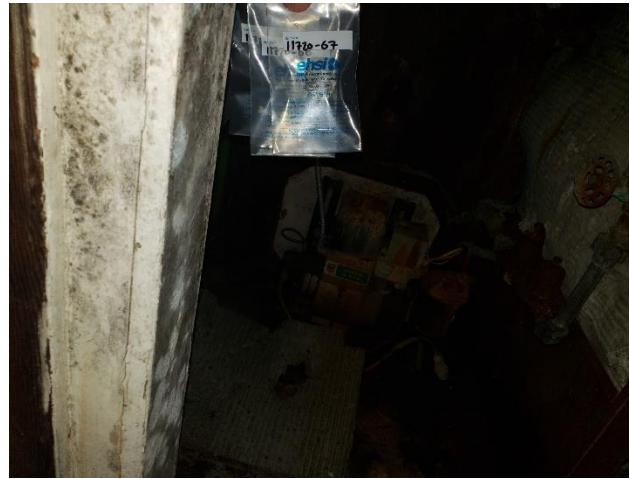
Photo #10: Samples 11720-67, 68 & 69: TSI lining (on boiler interior.) (85% Chrysotile)
Location: Building 7 Garage Area

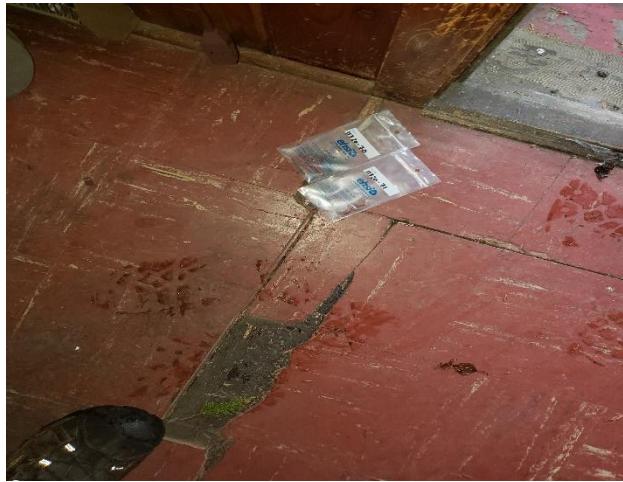
Photo #11: Samples 11720-70,71/71QA: 9"x9" Red VFT on black mastic (on wood.) (5% Chrysotile, <1% Chrysotile)
Location: Building 6 Living Room

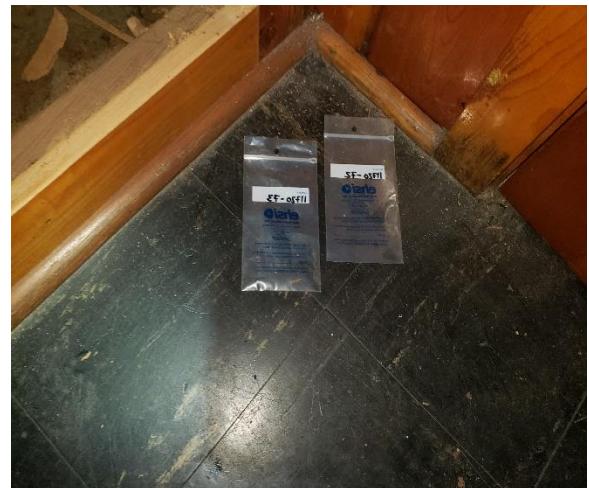
Photo #12: Samples 11720-72 & 73: 9"x9" Black VFCT on black mastic (on wood.) (4% Chrysotile)
Location: Building 6 Bedroom

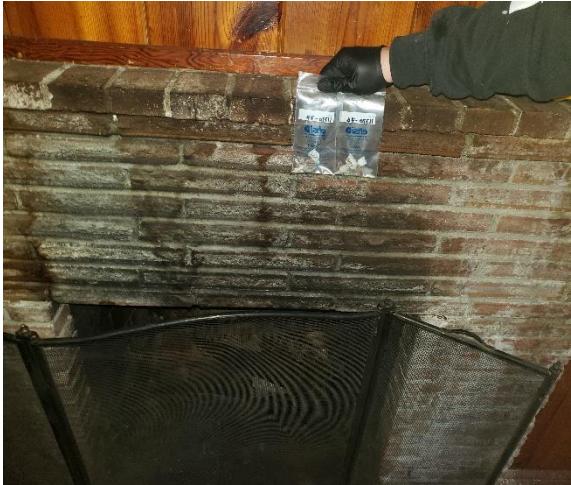
Photo #13: Samples 11720-76 & 77: Red external fireplace brick and gray internal fireplace brick on ACM mortar. (4% Chrysotile)
Location: Building 6 Living Room

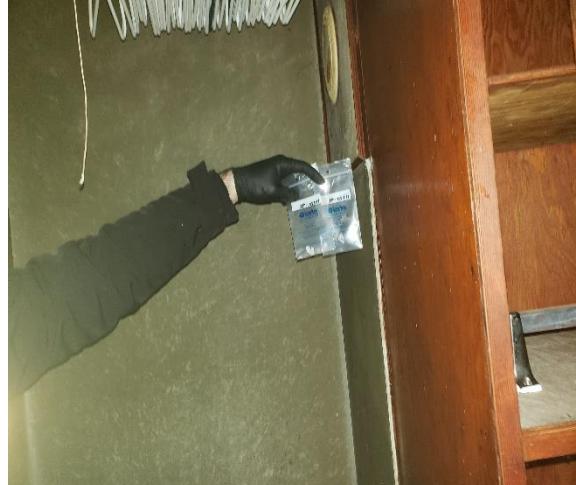
Photo #14: Samples 11720-91 & 92: Dark gray cement board paneling (on wood.) (31% Chrysotile)
Location: Building 5 Bathroom Exterior

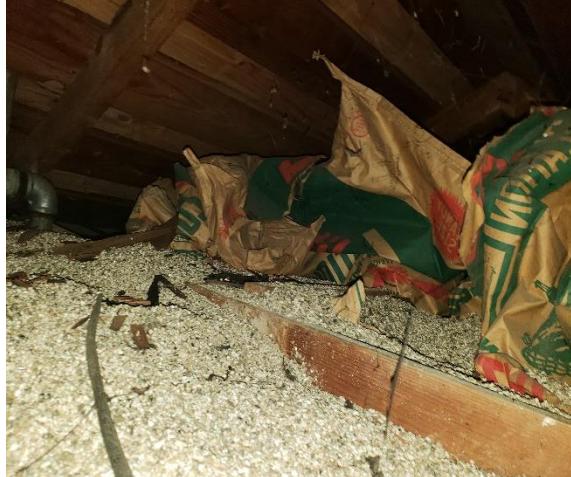
Photo #15: Assumed ACM vermiculite insulation.
Location: Building 6 Attic Space South

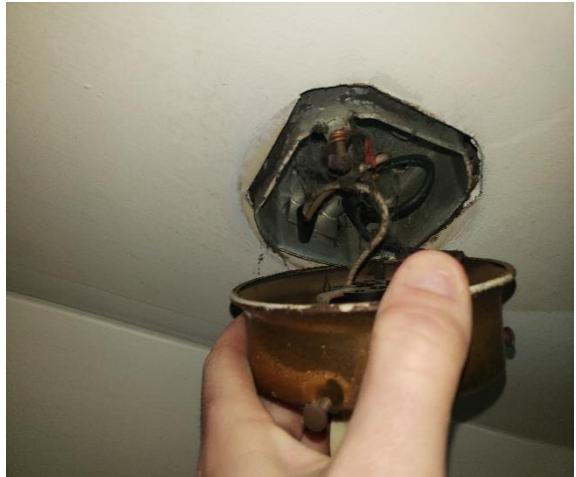
Photo #16: Assumed ACM cloth insulated electrical wiring.
Location: Throughout Buildings 2-9

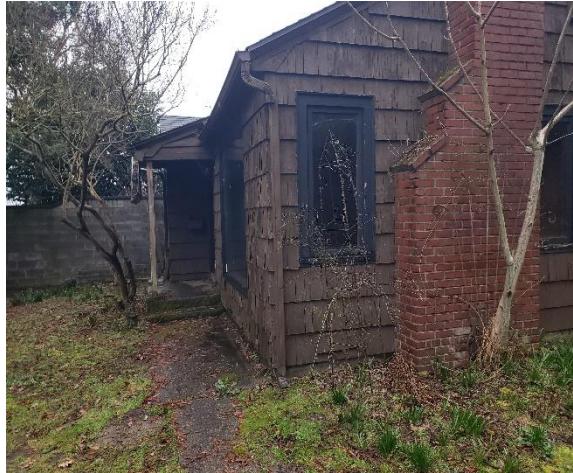
Location: Throughout Building 2-4

**Photo #17: Assumed ACM red and gray
fireplace brick with mortar.**
