Arborist Report

February 2025

Davey Resource Group Inc.

The client contracted Davey Resource Group Inc. (DRG) to provide an arborist report on the health, size, and location of the significant trees near the proposed cell tower construction site on Parcel #4027700071 and Parcel #4027700066 in Lake Forest Park, Washington. The subsequent report details all tree protection and retention measures. A [significant tree](#) is defined by the City of Lake Forest Park as an existing **live** tree that is not a hazard tree (i.e., a tree that does not have a high probability of failure due to a debilitating disease or structural defect) and that, when measured four and one-half feet above grade, has a minimum DSH (Diameter at Standard Height) of six inches.

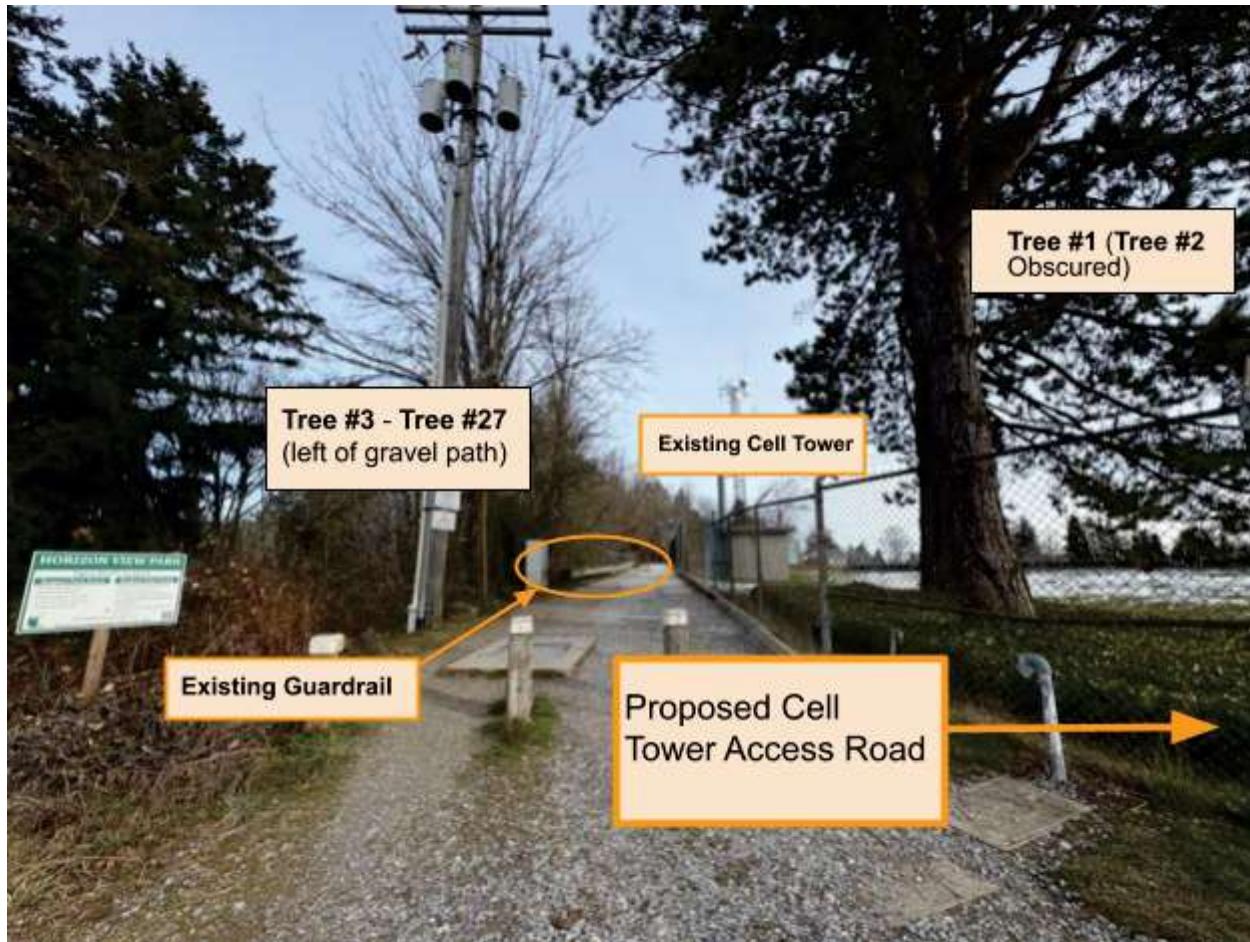
The site was located at 19701 47th Ave NE in Lake Forest Park WA, along the gravel path abutting the Lake Forest Reservoir. The path connects 45th Ave NE to Horizon View Park. The path is flat, well maintained and sees moderate foot traffic. There is a guard rail which protects pedestrians from a 5 foot vertical drop in elevation alongside the middle section of the path. The ground adjacent to the path has a moderate slope with a northwest aspect. The slope is forested with primarily *Acer macrophyllum* (Bigleaf Maple) and *Alnus rubra* (Red Alder) species, and has a dominant ground cover of *Hedera helix* (English Ivy).

Image 1: Path from 45th Ave NE to Horizon View Park, existing and proposed structures

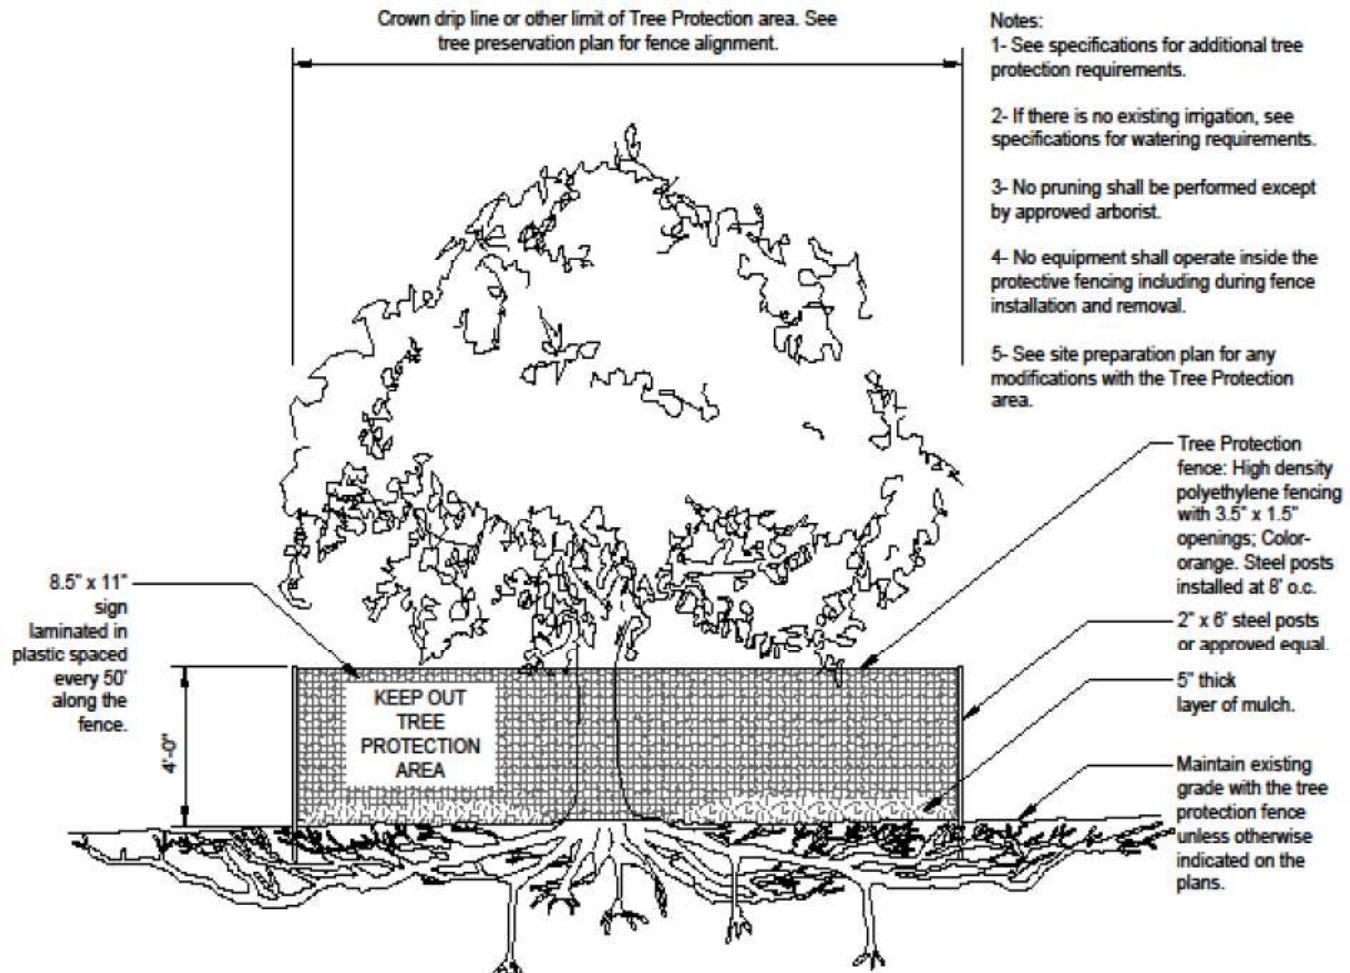
An example illustration of the location for the tree protection fencing. Fencing should be installed as far away from the tree trunk as allowable. At a minimum, it should be installed outside the CRZ. Any work within the TPZ should be supervised by a certified arborist.

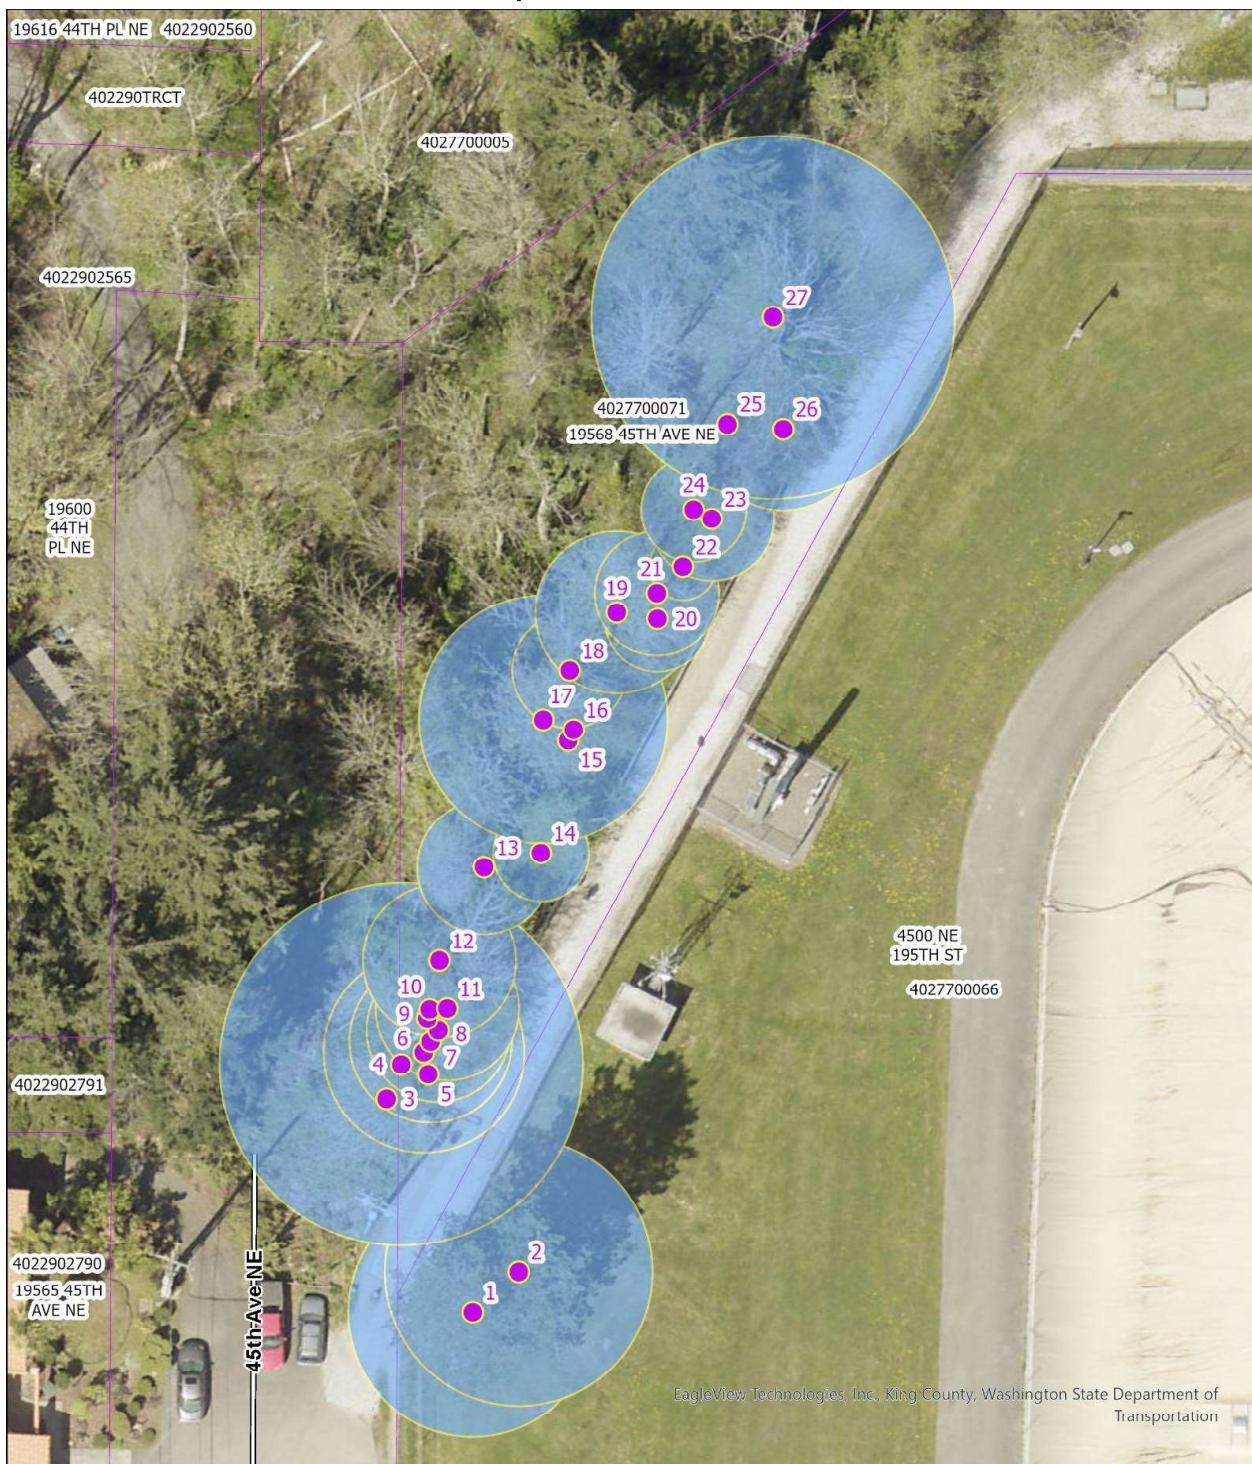
Map A1 - Site Overview

Construction of the proposed access road has the potential to injure the roots of Tree ID#s 1 & 2 and compress the surrounding soil, which could lead to tree death. The two trees are situated inside the barbed wire fence and are at the greatest risk of negative impact at the site. In order to preserve these trees, it is recommended to **move the proposed access road** to outside of their CRZs to ensure their survival. During this inventory these trees were not accessible, so it will be necessary to **confirm their DSH** on site to determine the radius of their CRZs. Although retaining these trees is ideal, if this is not feasible it is recommended to remove both trees and replace them according to Lake Forest Park standards for tree replacement ([16.14.090 Tree replacement](#)). If damaged by road construction but retained, not only could the trees themselves be harmed, but if they died the dead trees would pose a risk to those that use the access road. Additionally, both trees exhibited included bark in each of their codominant unions, indicating that cabling would help to even better ensure tree survival and site safety if the trees are chosen for retention.

Tree #4 and its adjacent trees are less likely to be impacted by construction activity, but it is still possible due to the proposed paving area, and/or if equipment is stored nearby. Tree #3 is the closest tree to the construction area but since Tree #4 has the greatest DSH and CRZ of the surrounding trees, protecting this tree will protect the ones in its vicinity. Tree Protection Fencing placed in an arc around the CRZ of Tree #4 and flattening at the edge of the gravel path will be sufficient to protect Tree #4 and all the trees behind it.

If retained, Tree #1 and Tree #2 will require mulching in order to protect the surrounding soil and support their health and resistance to stressors. Tree #3, Tree #4 and Tree #5 will also need mulching if construction or equipment storage will occur nearby. None of the other trees on this site will require mulching. Adequate mulching consists of a 3" layer of mulch or arborist chips.
