Property located at 4611 NE 178th Street in Lake Forest Park Washington contains a single-family home under construction on the property. Mature trees are present there and questions regarding excavation near mature trees arose.

On August 30, 2019 Kurt Fickeisen from Symbiosis Tree Care came to the 4611-property to observe excavation under the canopies of a Douglas fir (*Pseudotsuga menziesii*), a big leaf maple (*Acer macrophyllum*), and a black locust (*Robinia pseudoacacia*).

This report provides information on observations made during vactor truck excavation under tree canopies and a description of found roots and required root pruning.

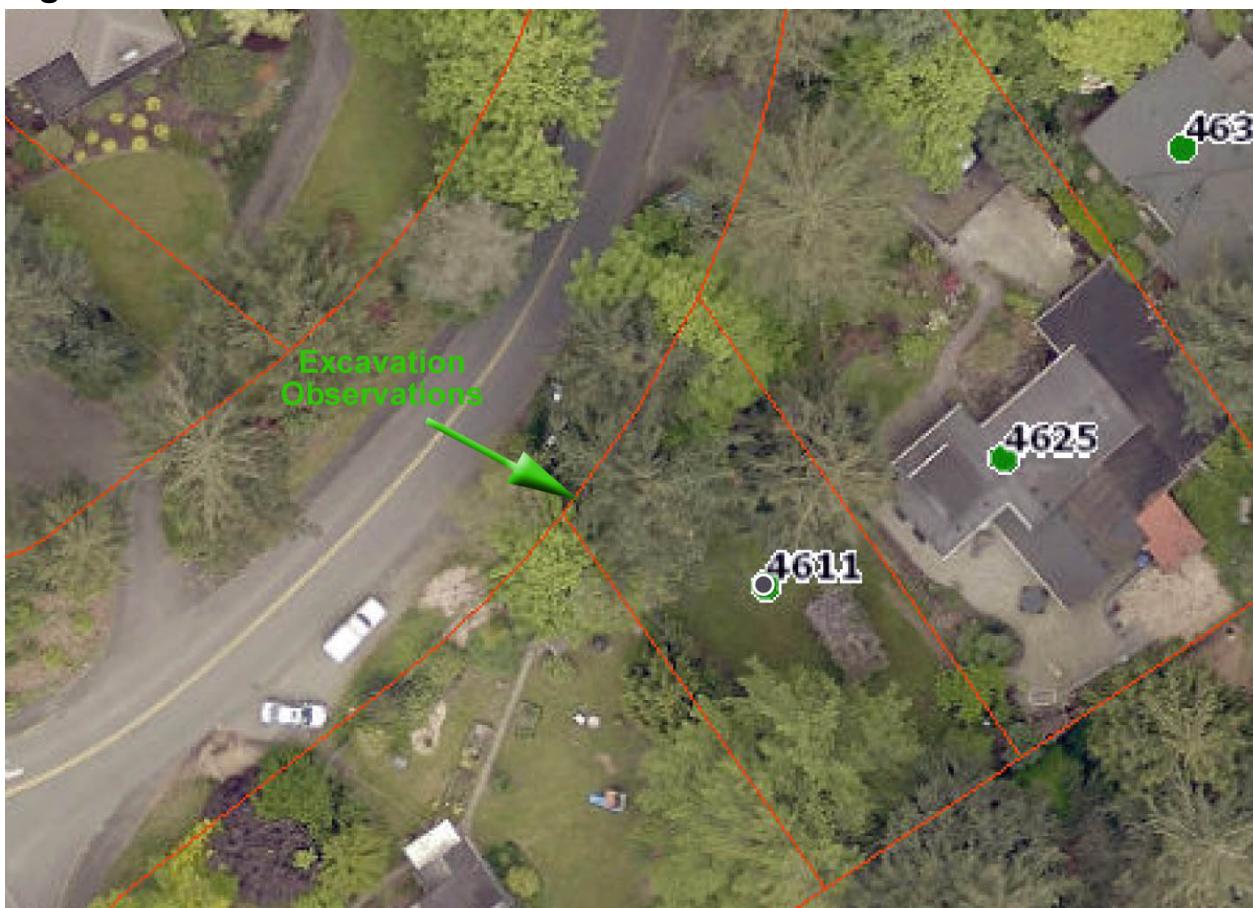
Figure-1

Excavation was performed with a water and a vactor truck and was observed by Kurt Fickeisen of Symbiosis Tree Care ([Figure-1](#), [Photo-1](#)).

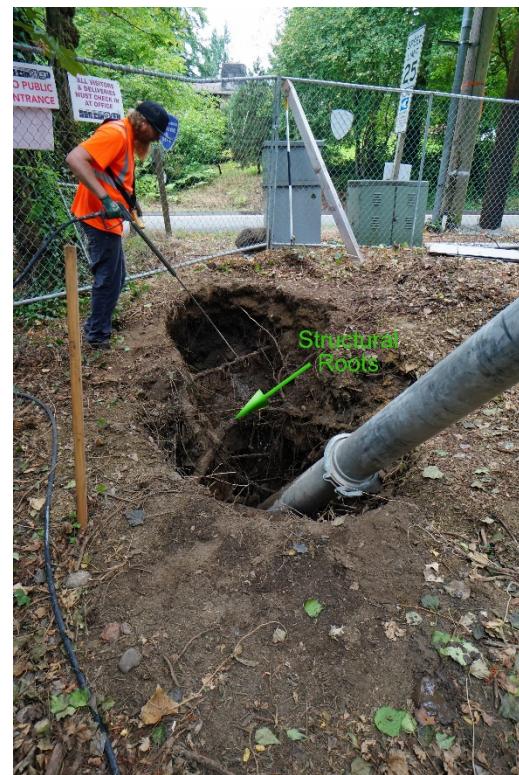
**Photo-2**

During the excavation process, structural roots with diameters greater than 3inches were encountered ([Photo-2](#)), but fine roots were also exposed ([Photo-3](#)).
