September 18, 2019

Property located at 4611 NE 178th Street in Lake Forest Park Washington contains a single-family home and is currently under development. Mature trees are present on the property and the adjacent 17586 Ballinger Way NE property. Questions regarding impacts of excavation on or near these trees arose.

Over five days between September 11 and 17th of 2019 Kurt Fickeisen from Symbiosis Tree Care came to the 4611 and adjacent property to observe excavation under the canopies of a Douglas fir (*Pseudotsuga menziesii*), big leaf maple (*Acer macrophyllum*), black locust (*Robinia pseudoacacia*), and a small codominant western red cedar (*Thuja plicata*).

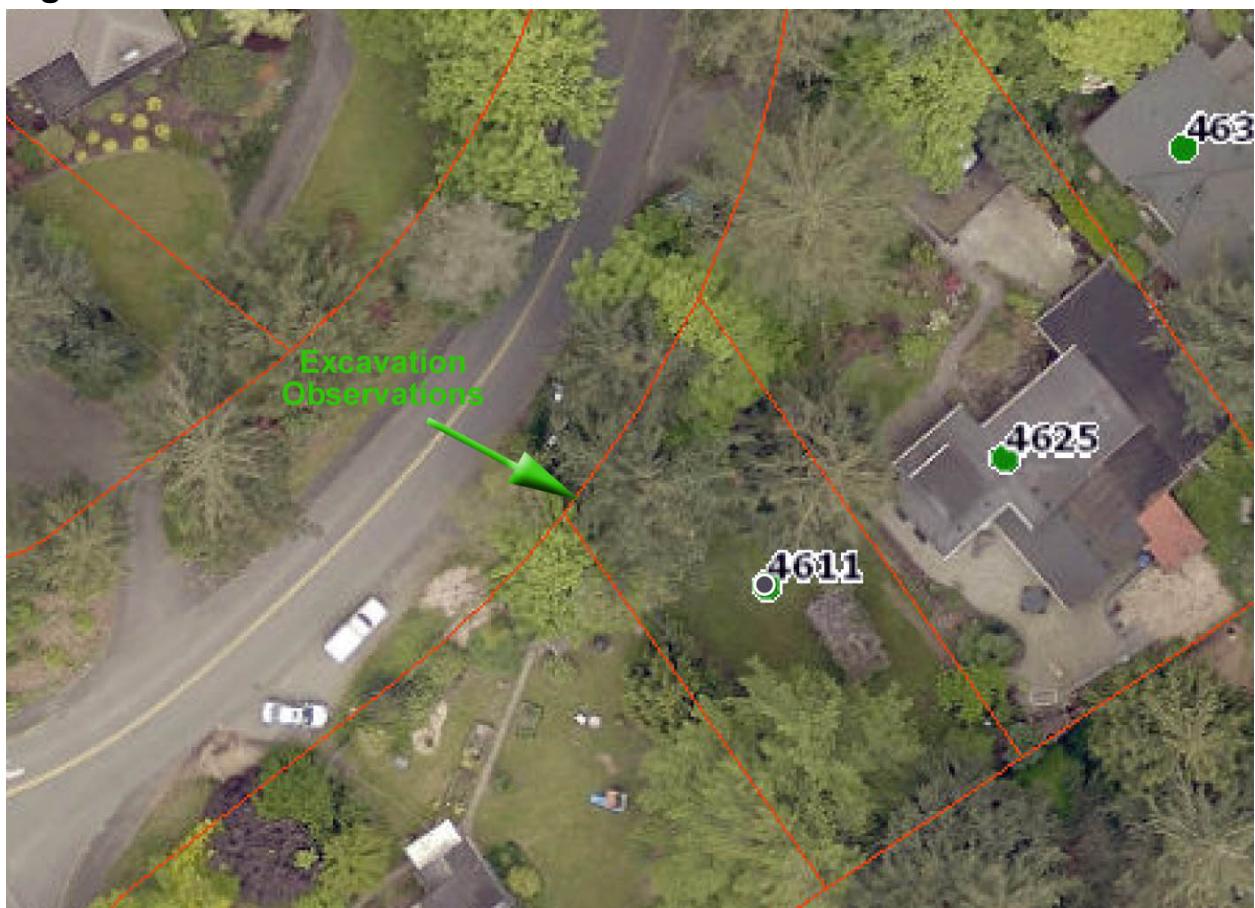
Figure-1

On September 11th, 2019 vactor truck excavation took place under the canopies of four trees (Figure-1, Photo-1). The following trees are within the area of excavation

- 52-inch diameter Douglas fir (Located on 4611-Property)
- 26.5-inch diameter black locust which is codominant at grade level (Located on 17586-Property)
- 22.5-inch diameter big leaf maple (Located on 17586-Property)
- Small and codominant western red cedar (Located on 17586-Property)

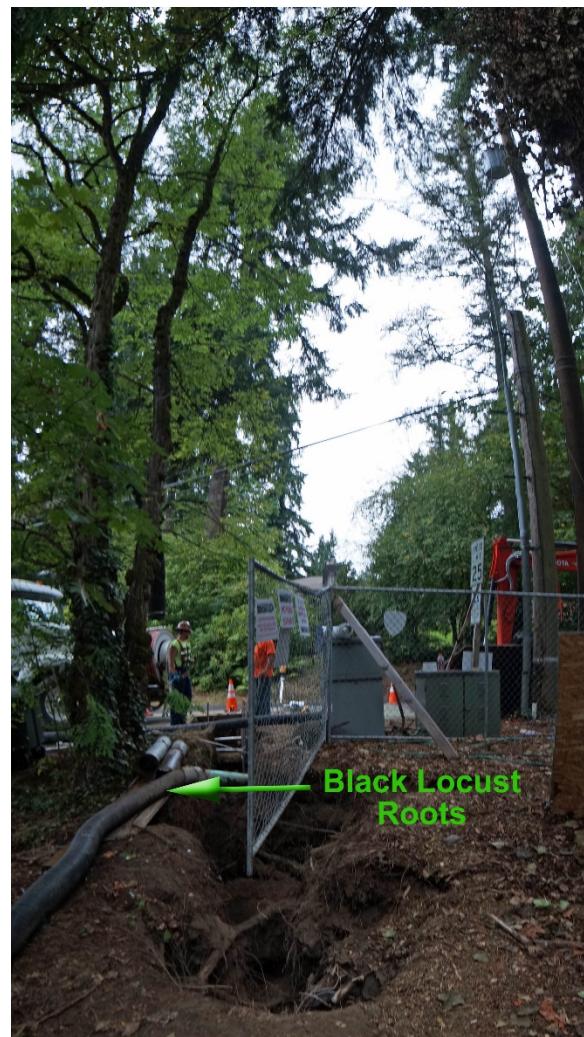
**Photo-3**

- Two 6-inch diameter black locust roots (Photo-3, Photo-4)
- Two 6-inch diameter big leaf maple roots and one 8-inch Douglas fir root (Photo-5, Photo-6)

Black locust roots were within 2-feet of space required for the new sewer line. These roots were cut or damaged during work as illustrated in Photo-4. Damages to these roots appear significant.

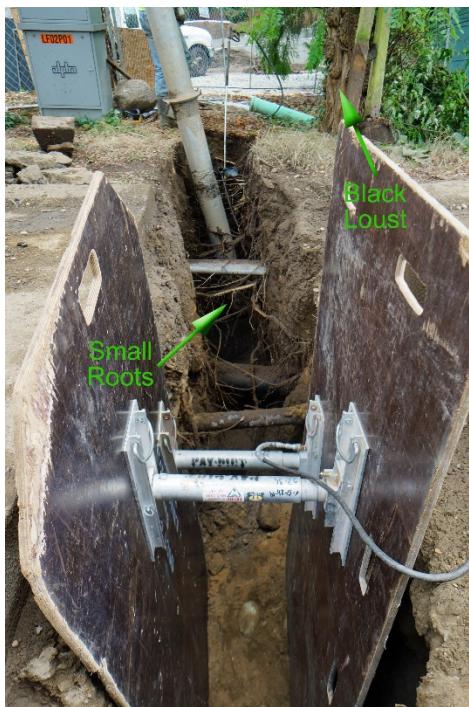
**Photo-2**

During excavation small diameter black locust roots were encountered and cut (Photo-2).

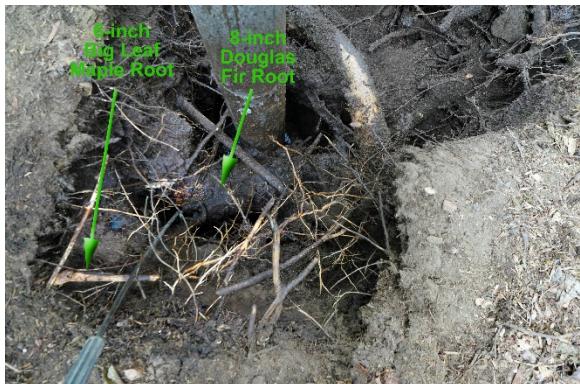
Photo-5

Structural roots connected to the big leaf maple and Douglas fir roots suffered damage (Photo-5, Photo-6)

- Damages to big leaf maples roots appear moderate to significant.
- Damages to Douglas fir roots appear minor

Since roots of trees on 17586-Property may have suffered root damage, 4-inches of arborist chips or compost should be placed on soil under tree canopies.

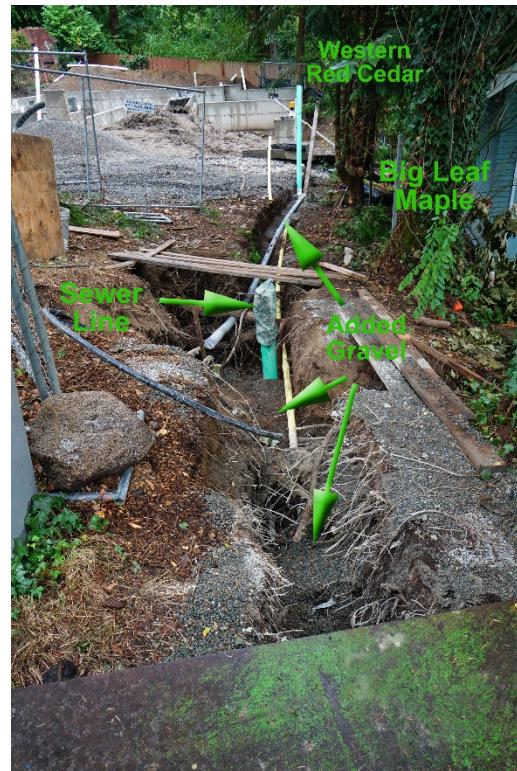
**Photo-7**

After excavation concluded, new sewer lines were set in place (Photo-6) and gravel was placed on soil and the material was added until sewer pipes were buried (Photo-7).
