CONSULTING ARBORIST MEMO OF SITE VISIT TO:

**S.M. CRANE GENERAL CONTRACTOR SITE
4611 NE 178TH ST.
LAKE FOREST PARK, WA. 98125**

CONSTRUCTION ACTIVITY REPORT

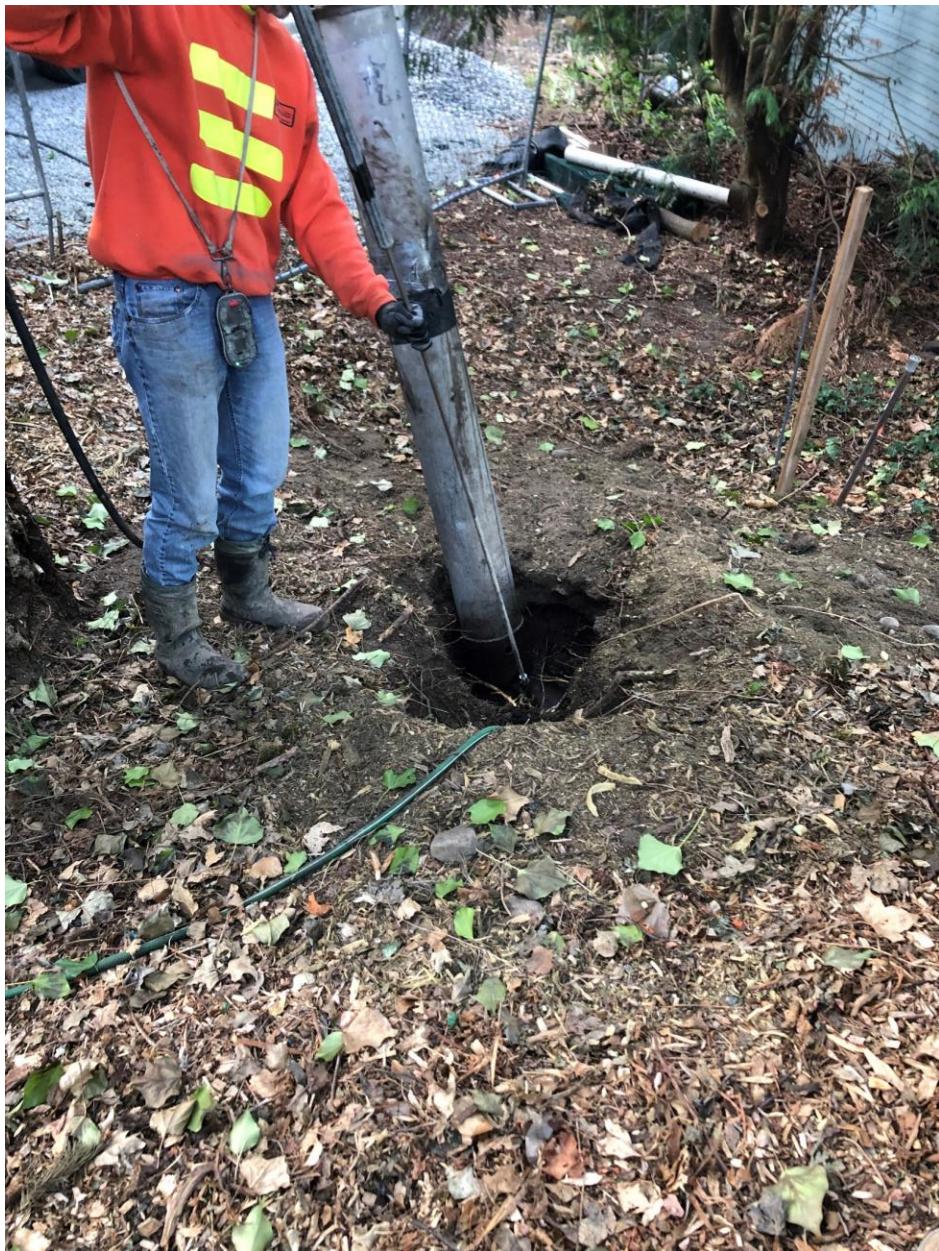
Hydro vaccuming within the ICRZ: I arrived on site today at 0800. The hydro vac truck set up on the Cel-Tec driveway to excavate within the ICRZ of the 52" Douglas fir tree, to unearth an old public sewer stub that was installed in approximately 1961, and to dig a utility line trench toward the new building foundation. Many roots were exposed in the first four feet of soil, however I believe most were from the nearby big leaf maple at the property corner, and from the black locust tree that had been removed several months ago.

The hydro vac process uses high water pressure to break up soil and rocks. It is impossible to avoid all the major roots from trees that are being retained, and some bark was knocked off the top of the larger roots. However, I asked the operator to avoid stripping bark from the underside of the roots so that they can remain viable to support the tree structurally and transport water and nutrients. Other and smaller roots were identified as belonging to the locust tree that was removed, and these were cut back, as needed, to provide access to the soil below. After three hours of hydro vac work, the sewer stub had not been located, and the decision was made to return in 7-10 with a larger truck and more flexible hose to continue the excavation. To my knowledge, no significant roots from the 52" Douglas fir were encountered. I left the site at 1100.

1. I advised the owner that he should focus on adding as much extra irrigation water as possible to this disturbed area for the next ten days.
