Consulting Arborist Memo of Site Visit to:  
SM Crane Construction Site: 4611 NE 178<sup>th</sup> St., Lake Forest Park  
October 10, 2019

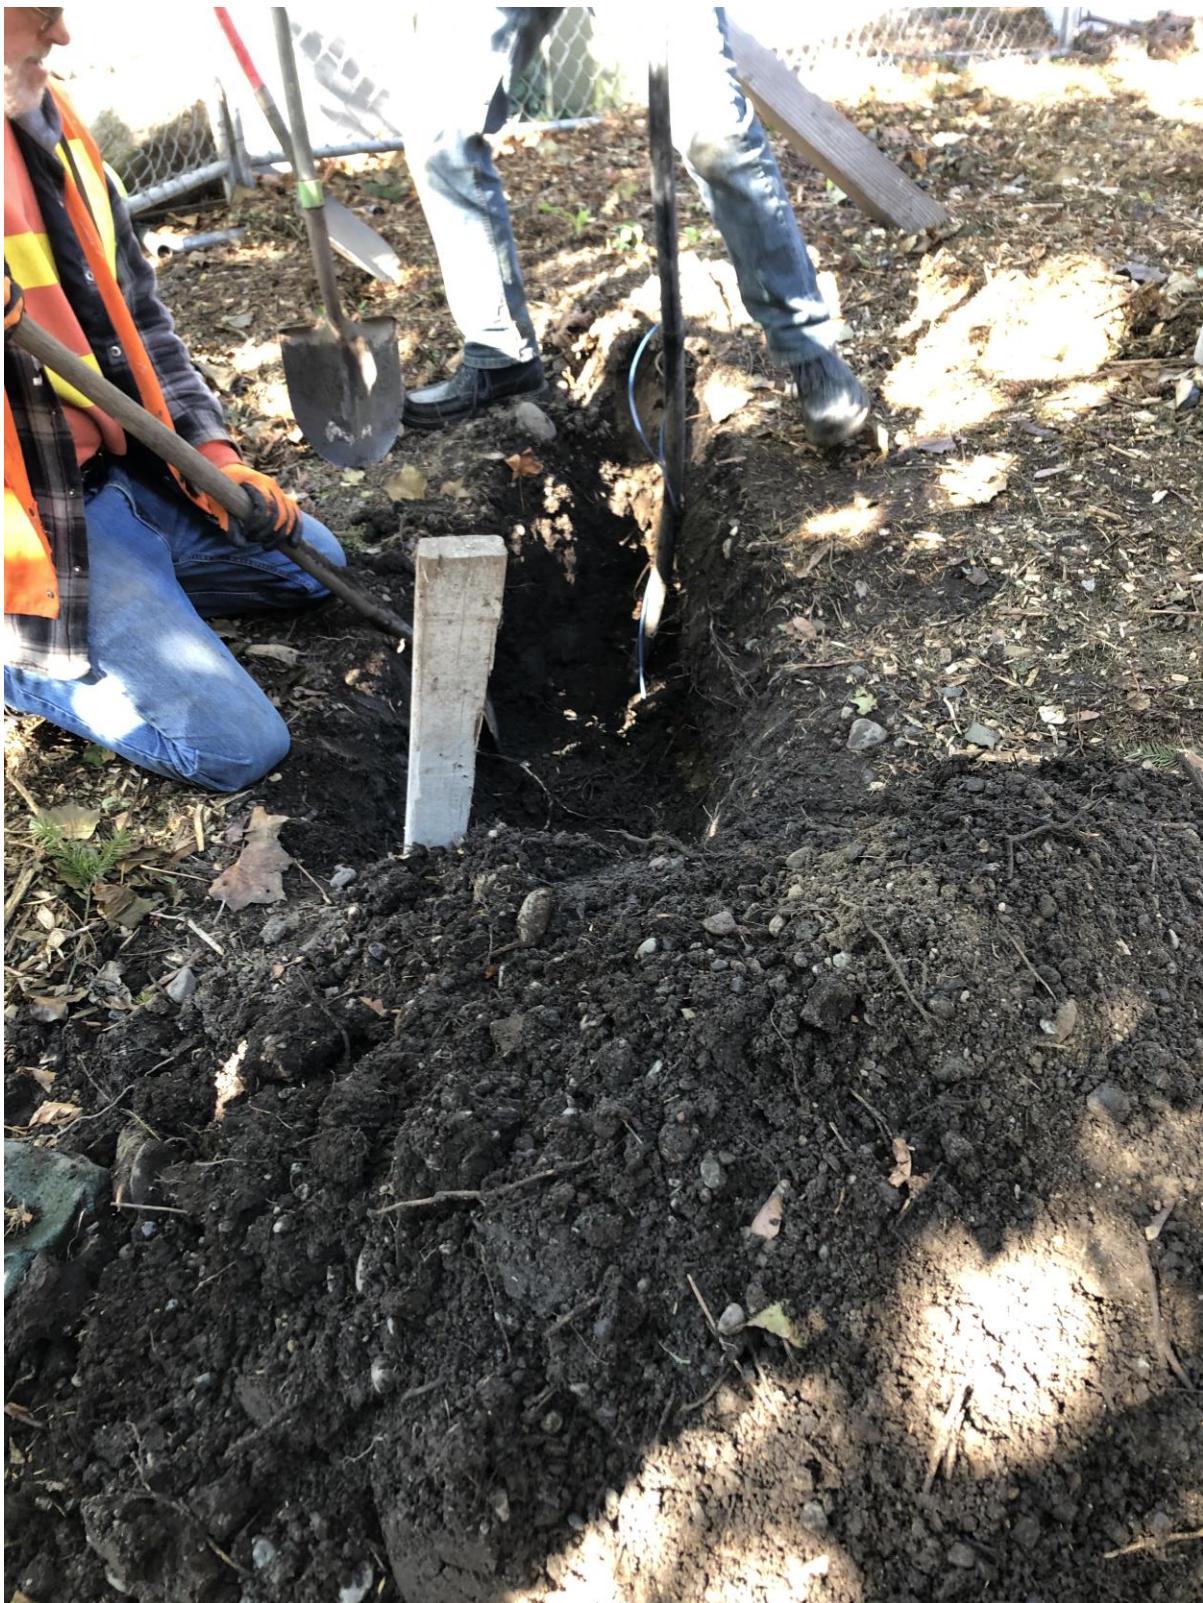
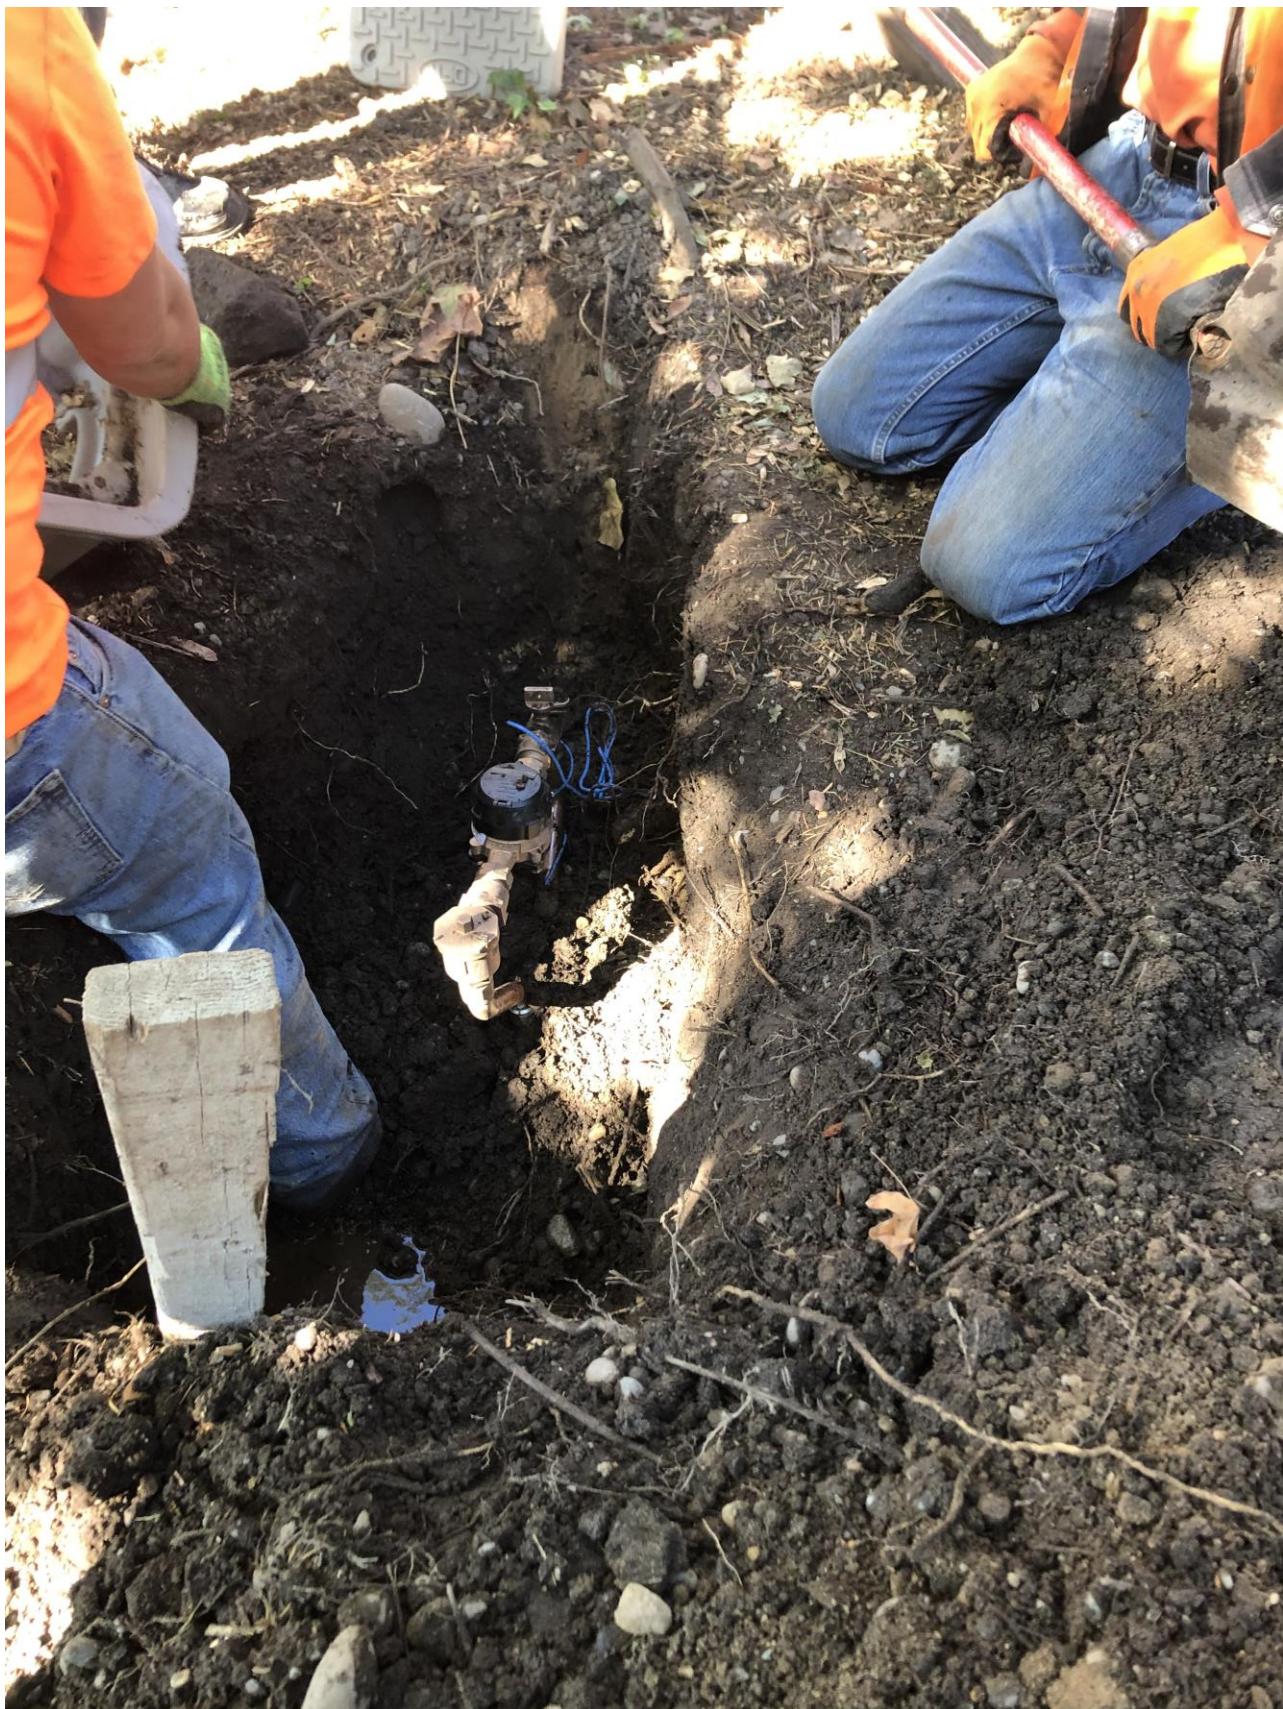
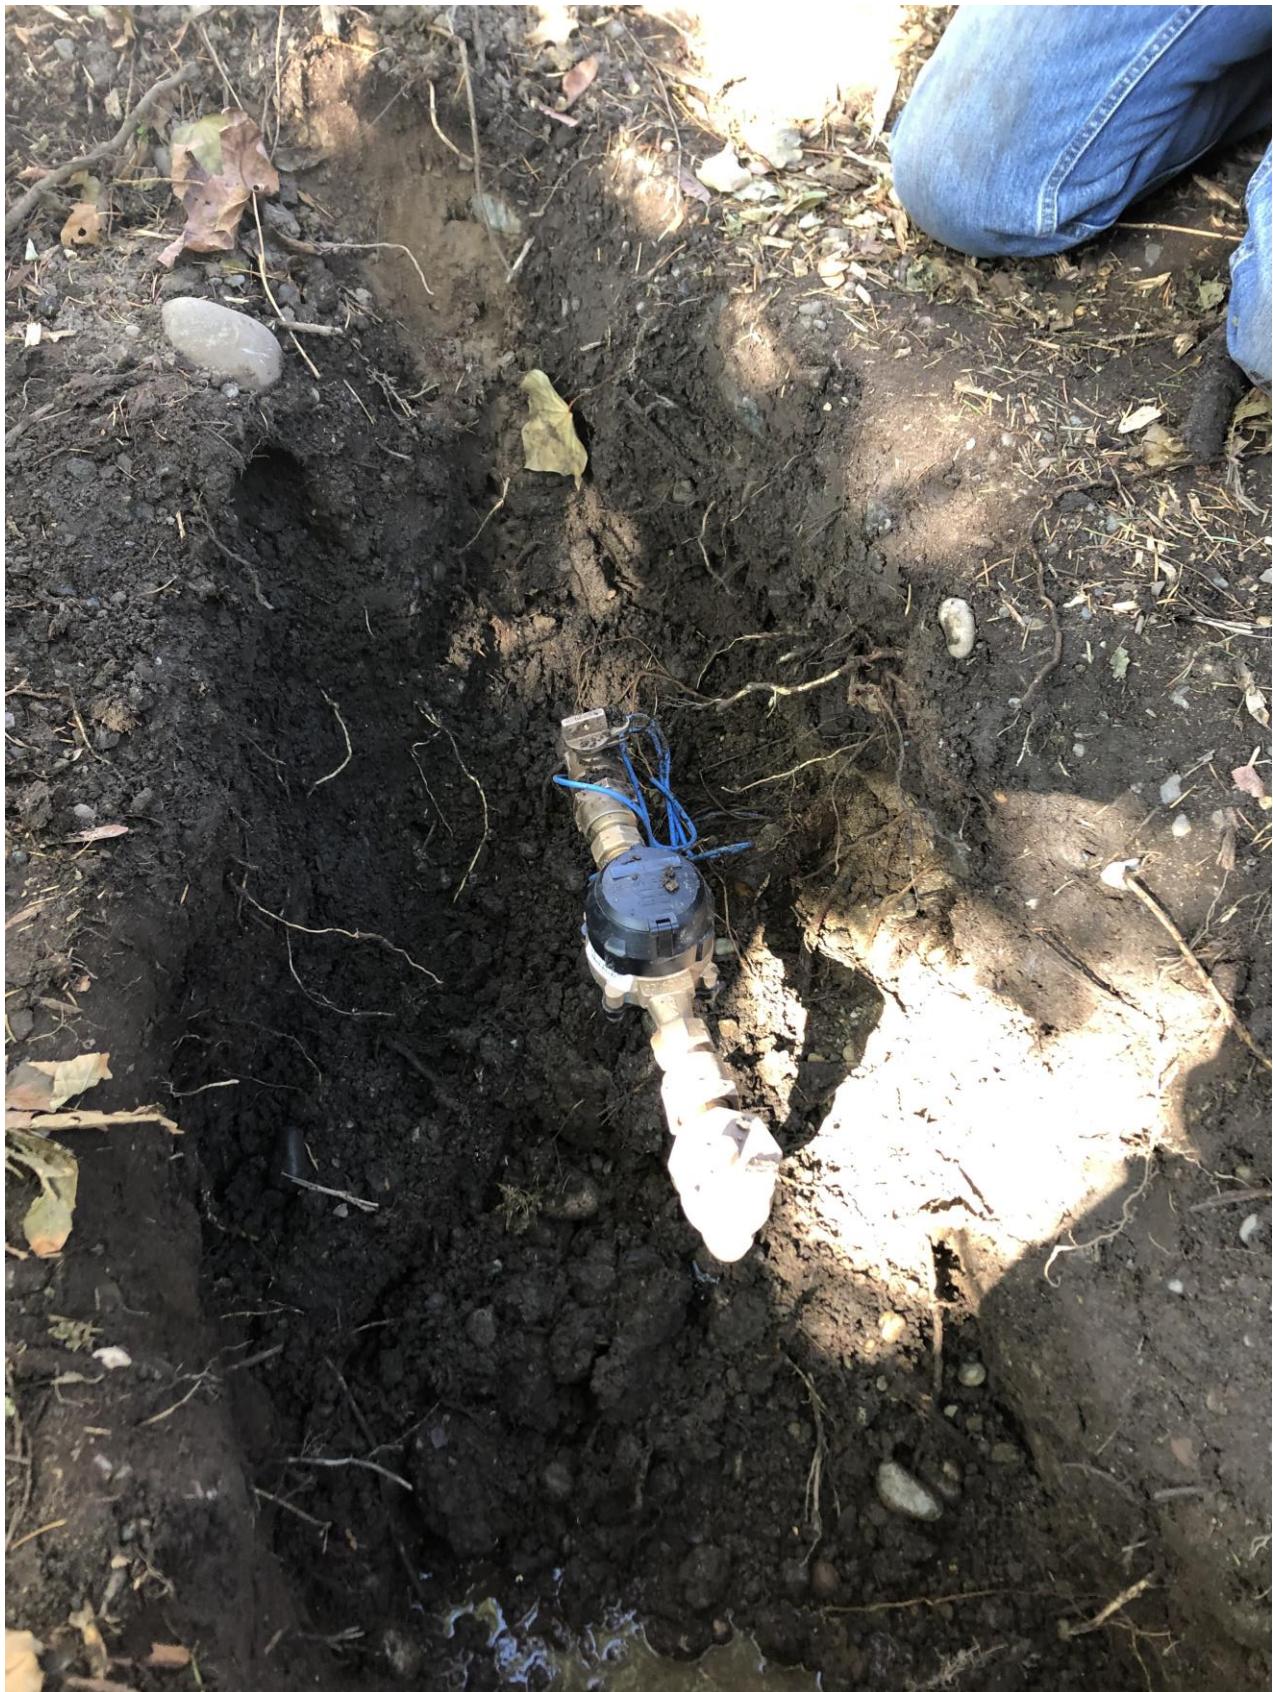
The purpose of my site visit on 10/10/19 was to observe the excavation within the ICRZ of the larger Douglas fir tree for the installation of the water meter. I arrived on the site at 1:45 PM and shortly thereafter the crew began hand digging the hole for the meter. The soil was very moist and they found only one 1" diameter root which had been previously pruned. Because the hole needed to be widened slightly at that point, I cut the root back to near the edge of the trench. I left the site at 2:55 PM as the crew was placing the meter box and backfilling the hole.

1. I observed that the soil moisture in this part of the ICRZ was very good. As the daytime temperatures drop, evaporative demand decreases, and soon the trees will enter semi-dormancy and rainfall will be adequate to supply the needs of the roots. I recommend that the owner water the entire ICRZ of both fir trees one more time.
