Reasonable Economic Use
Application

2020-RUE-0002

Type of Project:	Single Family Residential		
Property Owner:	Khoá Ha		
Owner Mailing Address:	7629 199 th ST SW LYNNWOOD WA 98036		
Phone:	206-235-0854	Email:	khoa.ha628@gmail.com
Property Address:	Vacant Land (No assigned address) Lake Forest Park, WA 98155		
Tax Parcel No:	4024100380		
Legal Description:	LAKE FOREST PARK 3RD ADD, PLat Block: 23, Plat Lot: 10		
Owner's Authorized Agent:	Jacob Strobl		
Authorized Agent Address:	3923 N 31st St, Tacoma, WA 98407		
Authorized Agent Phone:	206-661-3622	Email:	jacob@stroblsdesign.com

Preliminary Technical Information Report (TIR)

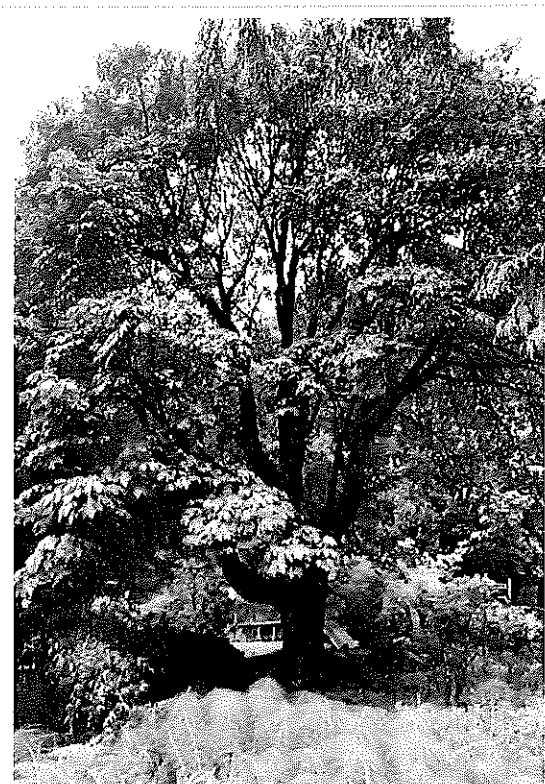
Photo 2: A view looking south at the neighboring bigleaf maple, tree #186. This tree will require pruning and tree protection.
